Victorian Heritage Database place details - 23/5/2019

HO200 - Hill, later Birch farm complex, 945 Eltham Yarra Glen Road, Watsons Creek

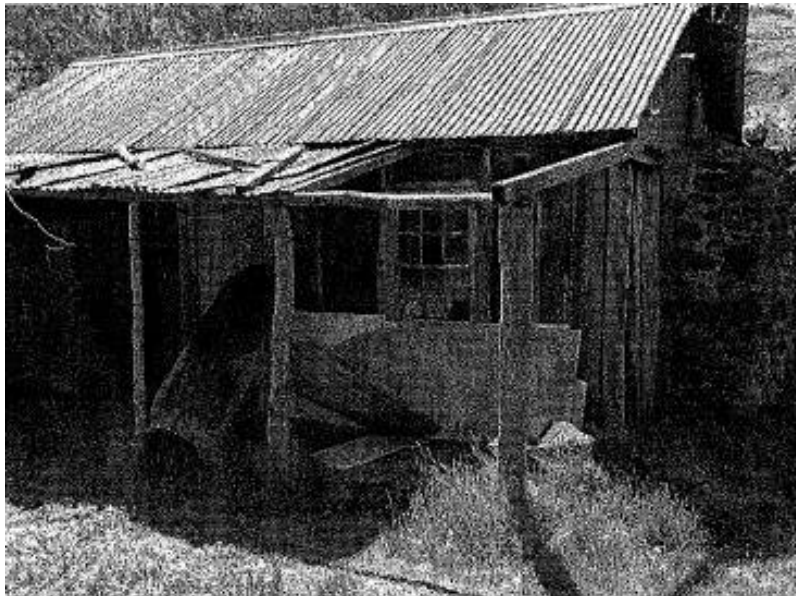
The house has a steep but simply gabled roof form clad with corrugated iron, vertical adzed hardwood slab front wall construction, split palings to the gable ends; rubble freestone chimney at one end (with added gsi flue), pole-framed Graeme Butler & Associates, 2006: 101 Shire of Nillurnbik Planning Scheme Amendment C13 Heritage Assessments verandah (rebuilt?); six-pane double-hung sash windows; T&G bead-edge boarded ledged & braced door; and paling clad rooms added at verandah ends. A slab-clad large fireplace is at the north corner of the house, with a gsi upper claddin added and an internal lining of rubble stone.

The rear facade is different construction, being drop-slab, and sits beneath a rear skillion addition to the main gabled form: this may be more recent construction. The house appears to have been once set up for public display and may have been recreated in part for that purpose.

Outbuildings are reached by a track along the east side of the house, including what may have been a creamery (typical standard inter-war design clad with corrugated iron and lined with 1938 Lysaght Queens Head Australia galvanised sheet iron) and a paling clad gabled out-house. Timber outbuildings of differing eras are to the north-west of the house, with pole framing and paling infill construction and Redcliffe brand corrugated iron. Post and rail (front) and split paling (rear) fence remnants line the front boundary. Pepper trees part of house yard landscape .
