Victorian Heritage Database Report
**Bell Rock Company Mine, near Bell Rock, Butcher Street
extension, ST ARNAUD**

Butcher Street ST ARNAUD, NORTHERN GRAMPIANS SHIRE

Heritage Study / Consultant	Northern Grampians - Shire of Northern Grampians - Stage 2 Heritage Study, Wendy Jacobs, Vicki Johnson, David Rowe, Phil Taylor, 2004
Construction Date Range	
Architect / Designer	
Municipality	NORTHERN GRAMPIANS SHIRE
Other names	
Hermes number	108359
Property number

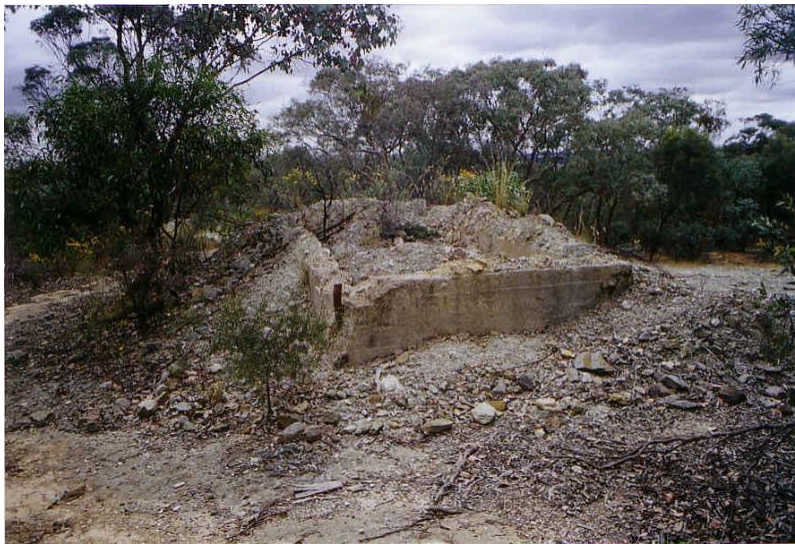
Site 79.0. Bell Rock Co. (The company erected a 20-head battery in 1875). Mine site. Largely intact mullock heap approximately 30 metres diameter and 10 metres high. On the south-west corner of the mullock heap is a partly excavated mullock paddock. No sign of the shaft on the mullock paddock but there are some iron mounting bolts exposed by the excavation. Battery site. To the north of the mullock heap is a small water dam. Between the dam and the mullock heap is a spread of red brick which marks the location of the battery. In the gully below the water dam is a small (20 metre wide) intact sludge pond. Tramway embankment/open cut. Above the battery site is a small (10 metre wide) open cut. Running from the open cut towards the battery site is the remains of a tramway embankment. Treated tailings. Between the sludge pond and the mullock heap is a small dump of treated tailings.

The mine site contains a range of features but unfortunately most of them have been disturbed.
