Victorian Heritage Database Report
Dodd Log Cabin

515 Olinda Basin Road, Olinda VIC 3788 - Property No 21240

Heritage Overlay Number: HO267

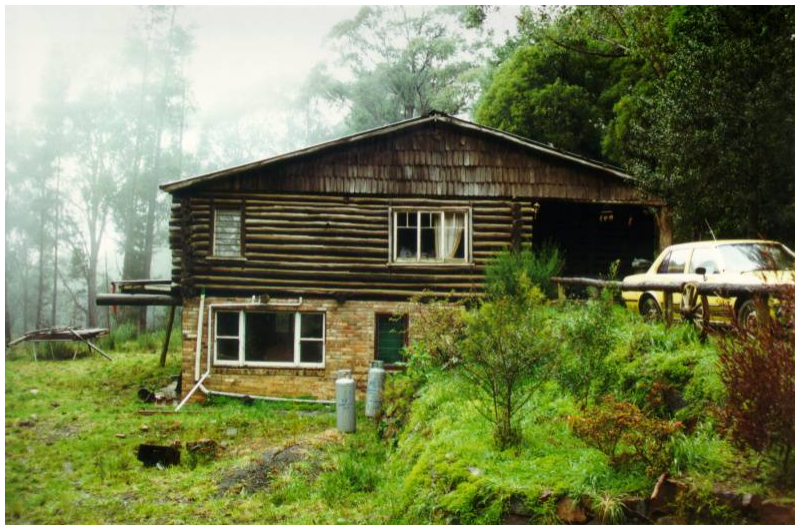
Dodd's Log Cabin is an unusual log cabin which dates, in part, from the 1880s. The house is located in an isolated, natural setting within 'Rainbow Gully' (Place No. 642). (Mrs Anne Swanson, daughter of Allan P. Dodd) It straddles a terraced clearing within the forest and overlooks the fern-covered hillside to the north.

Because of the terraced site, the rectangular plan house is predominantly single storey but includes a basement level to the north. The house has a gable roof and evidence of a balcony structure to the north.

The materials of the lower level suggest that the basement is a later inclusion. In contrast to the natural local materials of the upper storey and roof, the basement level is constructed from brick and incorporates a number of timber framed, c1930s windows which have a central, fixed pane and a double hung window either side.

The log cabin construction of the upper storey is an unusual and innovative example of the construction technique. The walls are made from logs laid horizontally, which overlap at each corner. A recessed verandah is located to the west elevation, which reveals a vertical log structure at the corner and the narrow cut timber used as ceiling joists. The gable end is lined with rectangular shingles and a long, slender log is used as a fascia. Timber battens can be seen between the fascia and the corrugated iron roof lining. A small curved piece of timber is arched to form a simple decorative bracket, connecting the corner post to the ceiling rafters.

The windows are irregularly placed and of various sizes and appear to have largely been replaced since the construction of the house in the late nineteenth century. Examples include a bank of three casements with timber framed, double pane highlights and louvred rectangular windows.
