**Victorian Heritage Database Report  
Maize Silos**

95 Station Road and 160 Station Road WESBURN, YARRA RANGES SHIRE

**Heritage Overlay Number: HO358**

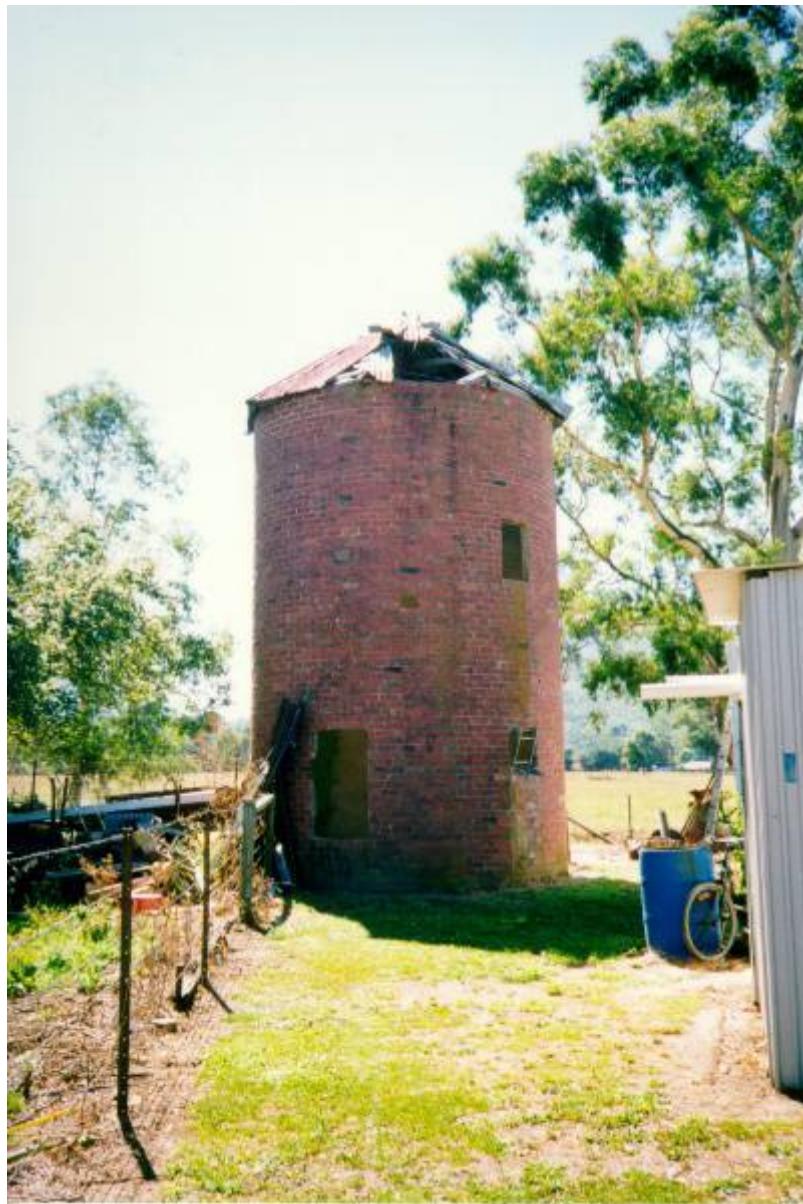
One of the maize silos is located at 95 Station Road. It is a brick structure, constructed of red bricks made by Hoffmans, a Brunswick brick manufacturer that operated from 1870s-1994. It is approximately 6 metres high, and is circular in plan. There are several openings in the structure that appear original. One appears to have been a doorway, and the purpose of the other two smaller openings is not known. One of these has been partially bricked up. Internally the structure is rendered. The roof framing is timber, using an umbrella-like form. Most of the roof framing survives as does part of the corrugated iron roof.

The other two maize silos are located on the adjoining property, 160 Station Road. One of these is a red brick structure, very similar in size and detailing to that at 95 Station Road. One difference is the two gabled roof openings (presumably for loading) that survive on this structure. The adjoining maize silo is substantially larger, and is probably constructed of concrete blocks. It is substantially intact. The roof remains and has a gabled opening. A metal ladder attached to the side of the structure provides access. Metal bands at each of three levels reinforce the structure. There are regularly spaced openings aligned with the position of the ladder. Nearby is a small building, the purpose of which is not known. These two silos and the nearby buildings were examined at a distance only, from the road, due to the possible disturbance to stock that may have resulted from a closer inspection.
