Victorian Heritage Database Report Wallace House

473 Warburton Highway, Seville VIC 3139 - Property No 14923

Heritage Overlay Number: HO300

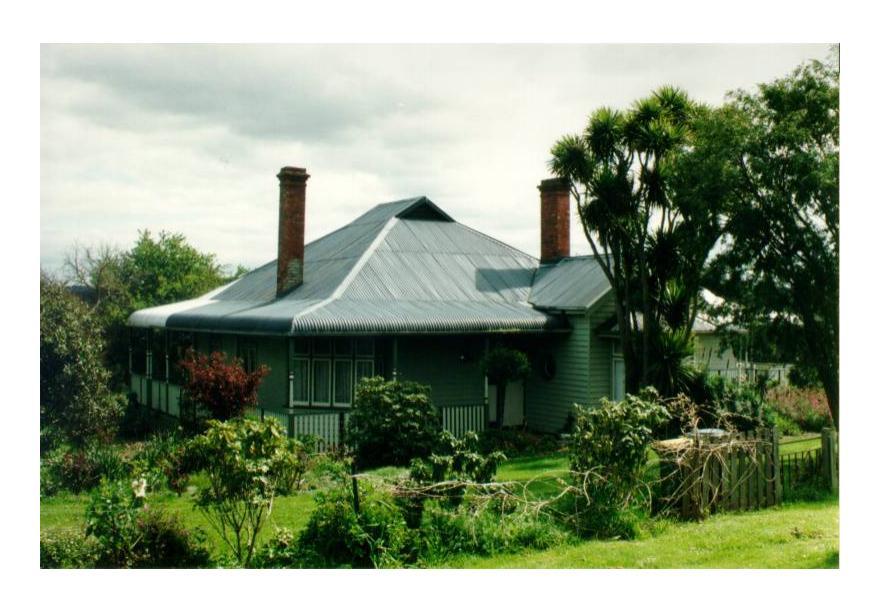
Wallace House is a substantial timber house situated to the west of the small centre of Seville, in a semi rural setting. The land surrounding the house is largely cleared, and the siting of the house in the hilly terrain makes it visible from the road making it a local landmark. A number of mature trees are located close to the house, including a mature cordyline to the south. Isolated sections of a low, plain picket fence remain on the Wallace Street property boundary.

Wallace House dates from the turn of the century and is a square plan timber house built in the Federation style. It has a combination of steeply sloped hipped and gable roofs with a return verandah and decorative timber work. The verandah extends from the projecting gable roofed section to the south-east corner along three side of the house. Its roof is an extension of the main hipped roof, with a shallower slope, and has a bullnose profile. This makes the roof the most dominant feature of the house. A modern addition built in the same style as the historic house extends from the east elevation around a courtyard garden.

Decorative elements include projecting bay windows, located on the south-west corner of the house beneath the verandah roof, and the separately roofed bay on the projecting wing facing Wallace Road. The bay windows each have a set of four rectangular, timber frame casement windows with square highlights, while the windows located elsewhere are double casements with similar highlight windows. A small porthole window is located adjacent to the main entrance. The verandah balustrade is constructed from panels of plain timber pickets between regularly spaced, turned timber posts.
