Victorian Heritage Database Report  
**Brook Hill**

17-19 MacIntyre Lane, COLDSTREAM VIC 3770 - Property No 4925

**Heritage Overlay Number:** HO69

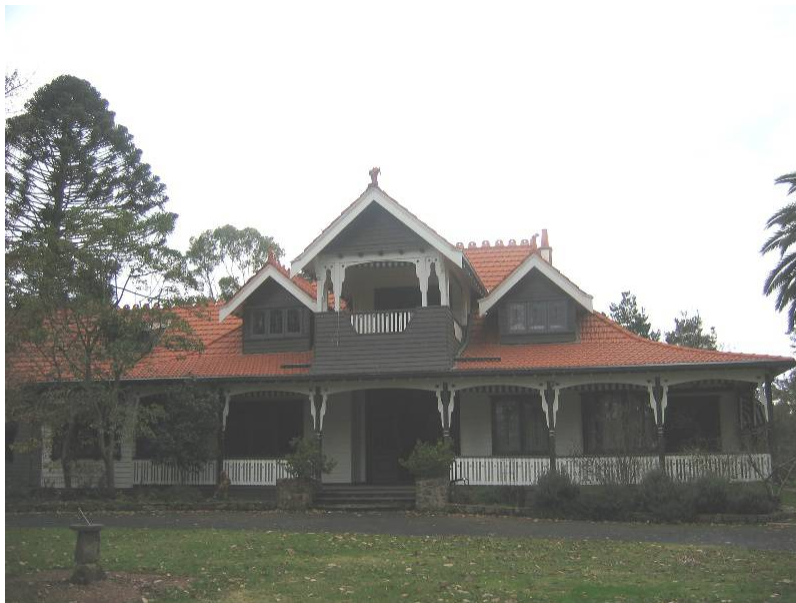
Brook Hill dairy farm contains a group of original and early farm buildings including the homestead, stables milking sheds and two silos.

The Edwardian Bungalow/Queen Anne style weatherboard house has a complex and picturesque terracotta tiled roof with ridge ornaments, exposed rafters at the eaves and slender roughcast chimneys with corbelled brick caps and terracotta pots. The roof extends over the front verandah supported on timber posts with decorative brackets and a timber fretwork balustrade. The roof has a gabled attic level balcony above the main entry with timber shingle cladding and a timber fretwork balustrade. Either side of balcony are gabled dormer windows with tripartite leadlight casements. The external walls have a timber framed roughcast frieze.
