Victorian Heritage Database Report
Ferny Creek Tea Rooms

70 One Tree Hill Road, Ferny Creek VIC 3786 - Property No 58141

Heritage Overlay Number: HO146

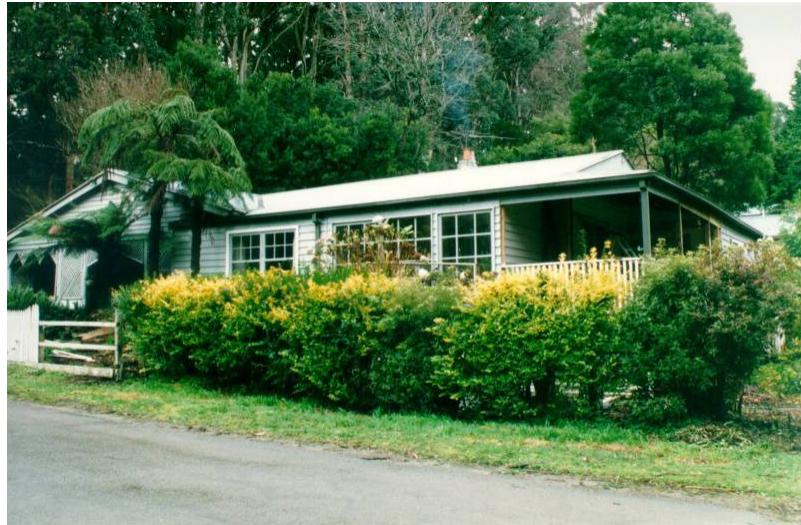
The structural remnants of the former Ferny Creek Tearoom are contained within the existing dwelling on the site. This dwelling is of historicised bungalow character and contains evidence of additional historic structures post-dating the Tearoom. The many additions and constant layering of change in the structure makes interpretation of the evidence extremely difficult.

However, a bush pole structure of some extent is very apparent in the west end of the existing dwelling and it is probable that this formed part of the early tearooms.

Only the one externally visible post on the west elevation remains. Internally, more is evident and the owner wishes to reveal even more in due course. Basically what remains of the original bush pole structure within the existing fabric is a grid of horizontal bush poles at roughly 2300-2400 (8 feet) intervals, supported at ceiling level about 2400 from the existing floor level. These cover an area of roughly 9m x 7.5m at the western end of the existing building, ie, four by three bays. The external bush pole posts are generally, but not always, at the intersections of the grid. Any original internal supports have been removed or are hidden in existing walls. The largest open area, comprising six bays, is supported within the living room at one point by an inverted turned verandah post. Most of the pole frame is hidden above the ceiling or boxed in by plasterboard. However in the bays closest to One Tree Hill Road the horizontal elements are revealed below a coved ceiling.
