Victorian Heritage Database Report

Maize Silos

95 Station Road and 160 Station Road WESBURN, YARRA RANGES SHIRE

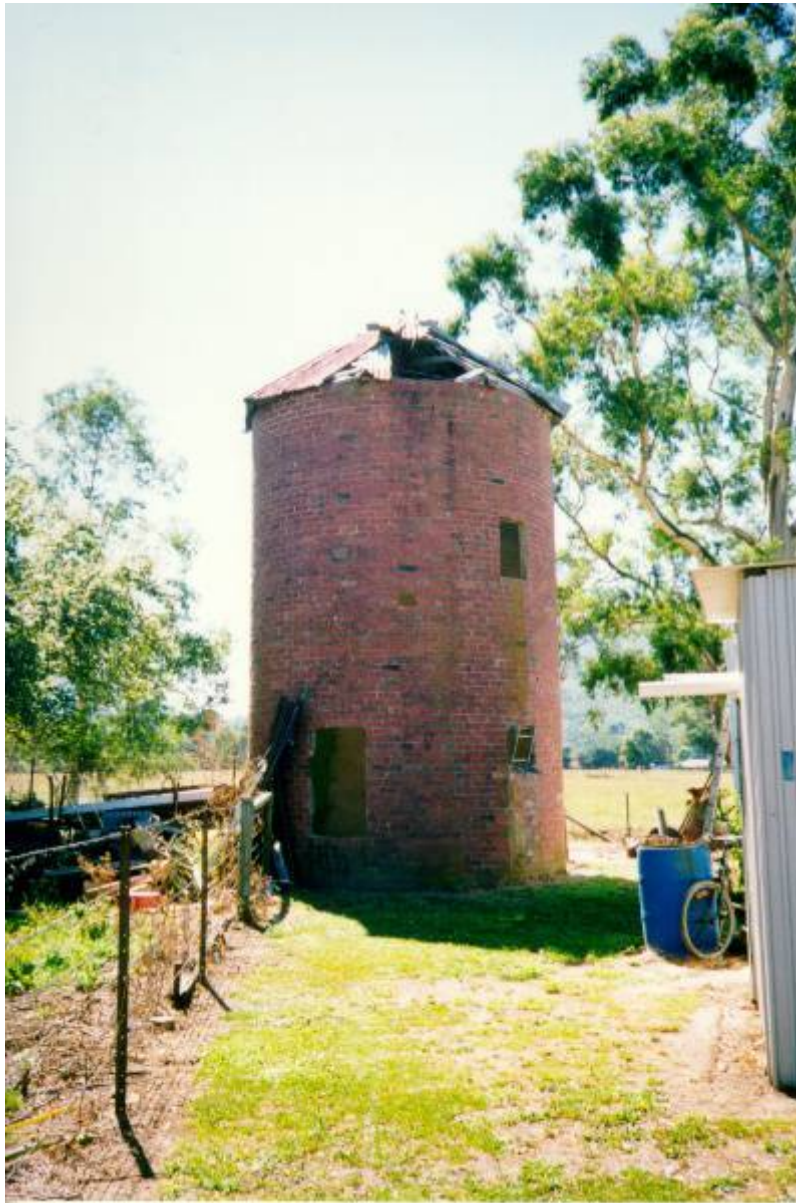
One of the maize silos is located at 95 Station Road. It is a brick structure, constructed of red bricks made by Hoffmans, a Brunswick brick manufacturer that operated from 1870s-1994. It is approximately 6 metres high, and is circular in plan. There are several openings in the structure that appear original. One appears to have been a doorway, and the purpose of the other two smaller openings is not known. One of these has been partially bricked up. Internally the structure is rendered. The roof framing is timber, using an umbrella-like form. Most of the roof framing survives as does part of the corrugated iron roof.

The other two maize silos are located on the adjoining property, 160 Station Road. One of these is a red brick structure, very similar in size and detailing to that at 95 Station Road. One difference is the two gabled roof openings (presumably for loading) that survive on this structure. The adjoining maize silo is substantially larger, and is probably constructed of concrete blocks. It is substantially intact. The roof remains and has a gabled opening. A metal ladder attached to the side of the structure provides access. Metal bands at each of three levels reinforce the structure. There are regularly spaced openings aligned with the position of the ladder. Nearby is a small building, the purpose of which is not known. These two silos and the nearby buildings were examined at a distance only, from the road, due to the possible disturbance to stock that may have resulted from a closer inspection.

Good

Minor Modifications
