Victorian Heritage Database Report  
**Maize Silos**

95 Station Road and 160 Station Road WESBURN, YARRA RANGES SHIRE

**Heritage Overlay Number: HO358**

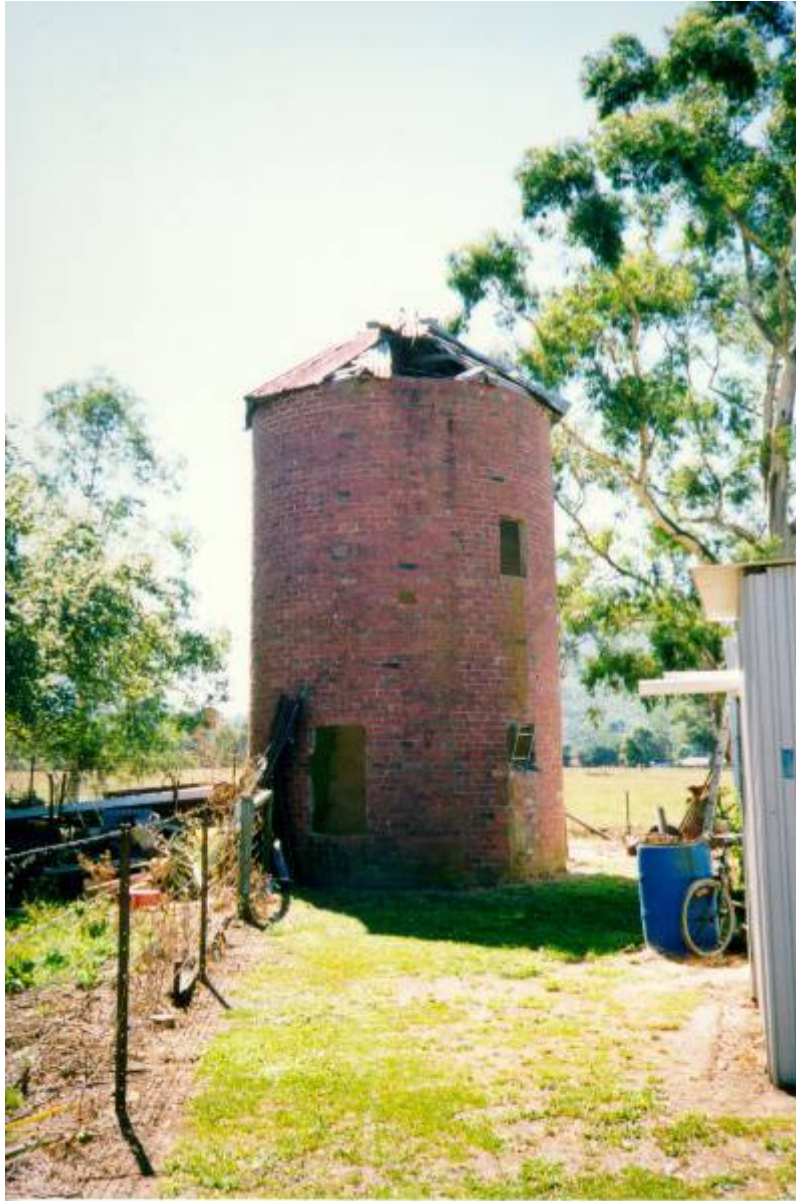
One of the maize silos is located at 95 Station Road. It is a brick structure, constructed of red bricks made by Hoffmans, a Brunswick brick manufacturer that operated from 1870s-1994. It is approximately 6 metres high, and is circular in plan. There are several openings in the structure that appear original. One appears to have been a doorway, and the purpose of the other two smaller openings is not known. One of these has been partially bricked up. Internally the structure is rendered. The roof framing is timber, using an umbrella-like form. Most of the roof framing survives as does part of the corrugated iron roof.

The other two maize silos are located on the adjoining property, 160 Station Road. One of these is a red brick structure, very similar in size and detailing to that at 95 Station Road. One difference is the two gabled roof openings (presumably for loading) that survive on this structure. The adjoining maize silo is substantially larger, and is probably constructed of concrete blocks. It is substantially intact. The roof remains and has a gabled opening. A metal ladder attached to the side of the structure provides access. Metal bands at each of three levels reinforce the structure. There are regularly spaced openings aligned with the position of the ladder. Nearby is a small building, the purpose of which is not known. These two silos and the nearby buildings were examined at a distance only, from the road, due to the possible disturbance to stock that may have resulted from a closer inspection.
