Victorian Heritage Database Report
Maize Silos

95 Station Road and 160 Station Road WESBURN, YARRA RANGES SHIRE

Heritage Overlay Number: HO358

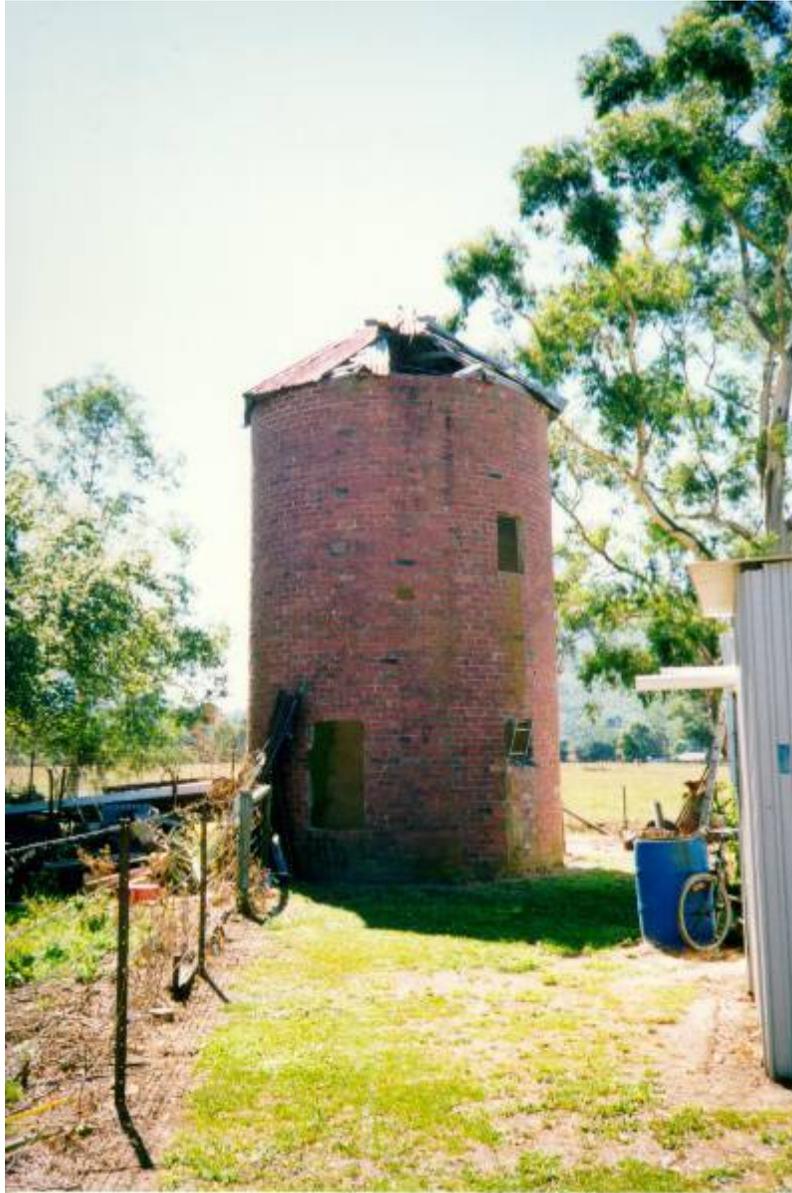
One of the maize silos is located at 95 Station Road. It is a brick structure, constructed of red bricks made by Hoffmans, a Brunswick brick manufacturer that operated from 1870s-1994. It is approximately 6 metres high, and is circular in plan. There are several openings in the structure that appear original. One appears to have been a doorway, and the purpose of the other two smaller openings is not known. One of these has been partially bricked up. Internally the structure is rendered. The roof framing is timber, using an umbrella-like form. Most of the roof framing survives as does part of the corrugated iron roof.

The other two maize silos are located on the adjoining property, 160 Station Road. One of these is a red brick structure, very similar in size and detailing to that at 95 Station Road. One difference is the two gabled roof openings (presumably for loading) that survive on this structure. The adjoining maize silo is substantially larger, and is probably constructed of concrete blocks. It is substantially intact. The roof remains and has a gabled opening. A metal ladder attached to the side of the structure provides access. Metal bands at each of three levels reinforce the structure. There are regularly spaced openings aligned with the position of the ladder. Nearby is a small building, the purpose of which is not known. These two silos and the nearby buildings were examined at a distance only, from the road, due to the possible disturbance to stock that may have resulted from a closer inspection.
