Victorian Heritage Database Report  
**Olinda Mechanics Institute**

69 Olinda-Monbulk Road, Olinda VIC 3788 - Property No 20088

**Heritage Overlay Number:** HO272

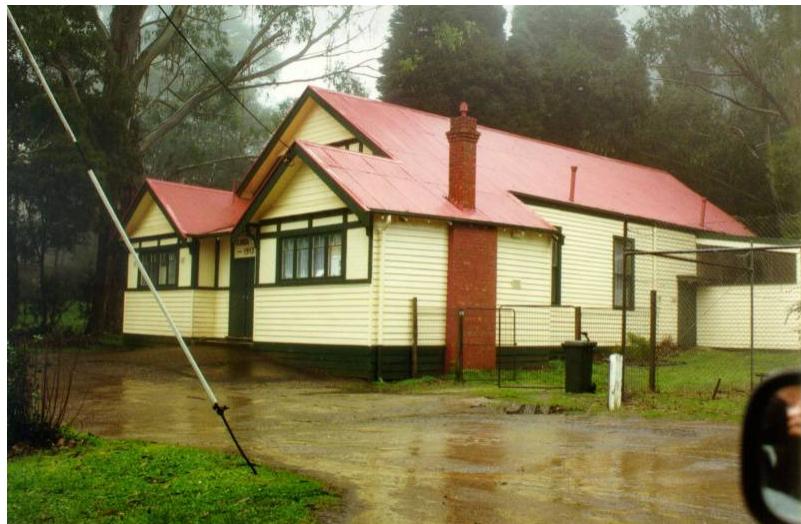
The Olinda Mechanics Institute, a single storey timber hall dating from 1913, is located in a natural setting, close to local community sporting amenities, including tennis courts. A curved driveway and cleared nature strip set the building back from the Olinda-Monbulk Road.

The Hall has a symmetrical facade which is dominated by a double height, rectangular plan central section with smaller projecting wings to either side. The rectangular plan wings extend back only a quarter of the length of the main hall and their gable roofs are, in part, an extension of the main roofline. The roof of the eastern wing is pierced by a brick chimney, which is partially expressed in the external wall below. A timber lined, built-in verandah connects the three elements on the street facade and a sign over the entrance lists the name and construction date of the building.

The Hall is timber lined and elevated in part to accommodate the gentle slope of the land. The base of the building has been lined with timber slats. The corrugated iron lining the roofs and verandah has been painted red, and include overhanging eaves and bargeboards to the flanking wings. The gable ends to each section of the Hall are identical, with overhanging bargeboards and timber lining moulded to simulate shingles.

Casement windows have been used on the street facade, and are mounted on the outside of the wall face. The windows are banked in groups of four and are surrounded by timber strapping and stucco boards. Windows to the side elevations of the main hall are vertical, timber framed, double hung windows.
