Victorian Heritage Database Report  
**Olinda Mechanics Institute**

69 Olinda-Monbulk Road, Olinda VIC 3788 - Property No 20088

**Heritage Overlay Number:** HO272

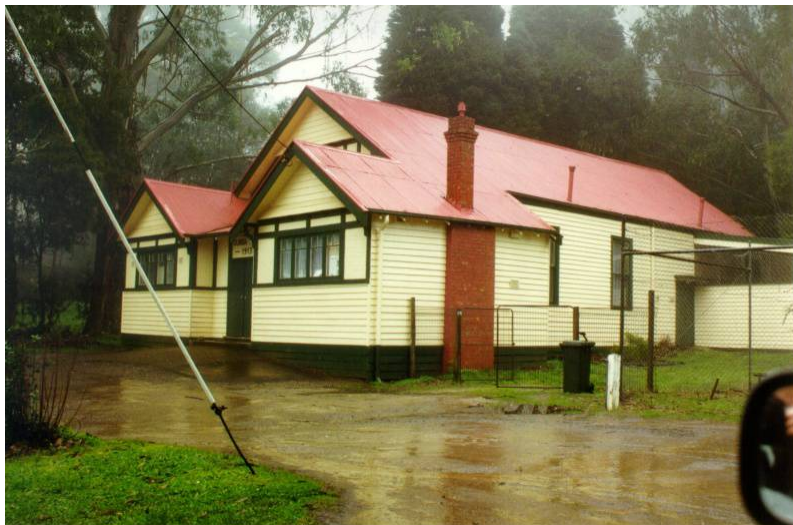
The Olinda Mechanics Institute, a single storey timber hall dating from 1913, is located in a natural setting, close to local community sporting amenities, including tennis courts. A curved driveway and cleared nature strip set the building back from the Olinda-Monbulk Road.

The Hall has a symmetrical facade which is dominated by a double height, rectangular plan central section with smaller projecting wings to either side. The rectangular plan wings extend back only a quarter of the length of the main hall and their gable roofs are, in part, an extension of the main roofline. The roof of the eastern wing is pierced by a brick chimney, which is partially expressed in the external wall below. A timber lined, built-in verandah connects the three elements on the street facade and a sign over the entrance lists the name and construction date of the building.

The Hall is timber lined and elevated in part to accommodate the gentle slope of the land. The base of the building has been lined with timber slats. The corrugated iron lining the roofs and verandah has been painted red, and include overhanging eaves and bargeboards to the flanking wings. The gable ends to each section of the Hall are identical, with overhanging bargeboards and timber lining moulded to simulate shingles.

Casement windows have been used on the street facade, and are mounted on the outside of the wall face. The windows are banked in groups of four and are surrounded by timber strapping and stucco boards. Windows to the side elevations of the main hall are vertical, timber framed, double hung windows.

A recent, timber lined skillion roofed addition is located to the rear, east corner of the main hall.

Good

Minor Modifications
