Victorian Heritage Database Report

## Real Thing Crafts and Noel's Piehouse Café

4 Parsons Lane, OLINDA VIC 3788 - Property No 20068

**Heritage Overlay Number:** HO275

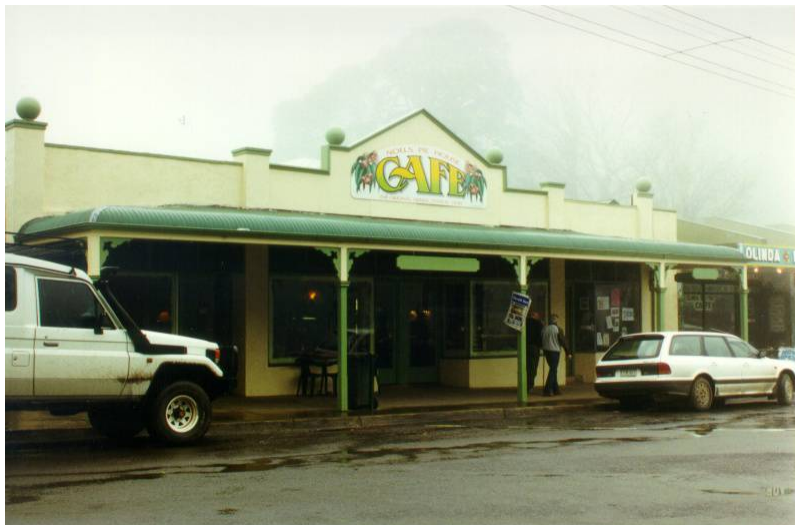
Noel's Pie House is located within Olinda's commercial centre and was built after 1939. The Pie House is a single storey, twentieth century, rendered brick building which encompasses three shopfronts. It has a rendered parapet delineated by capped pilasters to mark the extent of each shopfront. The central, and largest shop is crowned with a rendered pediment. Both the pediment and extent of the building are marked with decorative spherical elements.

The street facade has large, rectangular, plate glass windows with multi-pane highlight windows above. The entrance to each shopfront is recessed and includes splayed panels to either side. The central shop has double doors to the entrance, while the smaller shop either side have single doors.

The recently constructed verandah has a bullnose profile and is lined with corrugated iron. Decorative carved brackets flank each square section, timber verandah post.

Immediately west of Noel's Pie House, but separated from it by a narrow alley, is The Real Thing Craft Centre, which was also built after 1939. It is a modestly scaled, single storey, narrow shop built to the street line. It has a rectangular plan with a symmetrical facade dominated by a timber-lined gable end roof form.

The shopfront has timber framed, multi pane windows with a base of face brickwork to each side of the centrally located entrance. The cantilevered gable end is supported on regularly spaced decorative timber brackets. The horizontal timber lining boards to the gable end have been scalloped to imitate the profile of timber shingles.
