# Victorian War Heritage Database Place Details - 24/8/2025

## Sherbrooke Lodge

35 Sherbrooke Lodge Road, Sherbrooke VIC 3789 - Property No 58665

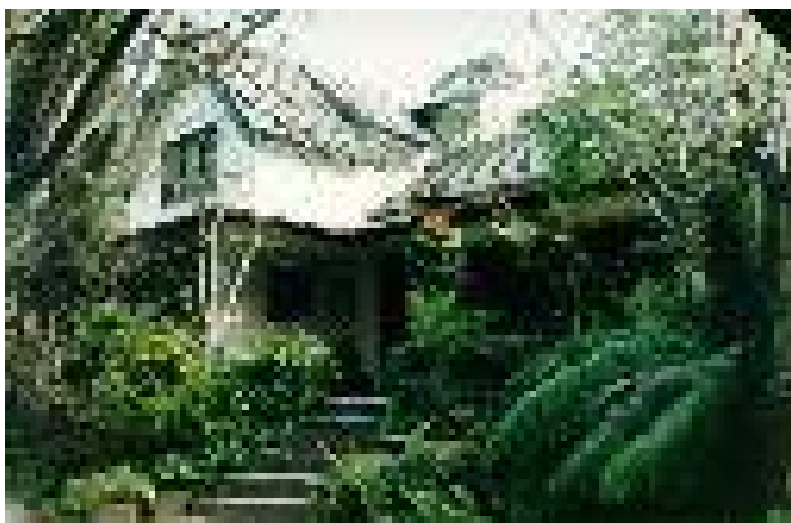
Sherbrooke Lodge is located on the northern perimeter of the Sherbrooke State Forest in a large, landscaped property. The house is built on a levelled platform within the sloped site, overlooking a landscaped garden. Planting lines the retaining walls to much of the elevated house and the garden has an impressive selection of mature indigenous and imported trees and shrubs. A series of gravel paths and lawned areas delineate the garden which also includes terraced areas lined with stone in an irregular, random pattern. The stonework may date from the 1960s. Sherbrooke Lodge is currently used as a reception centre.

The former guest house has asymmetrical massing with a combination of single and double storey elements, dating from different eras. It has undergone a series of alterations and additions over time, changing both the form of the house and many of the original details. Much of the building appears to date from the post world war one era, however a small cottage to the north-west corner may be a pre-war structure. Modern additions have generally been to the east of the building and are unsympathetic to the massing, style and materials of the building.

Sherbrooke Lodge is dominated by a single storey, transverse gabled roof section which forms the main spine of the building. It terminates to the west in a two storey wing and to the east in a combination of single and double storey skillion roofed additions. The gabled roof is clad with tiles and includes a small roof overhang with exposed rafters to the eaves. The projecting wing to the west extends beyond the building line to the north and south and has an intersecting gable end roof form which extends above the ridge line of the main roof. The walls are variously constructed from a combination of rendered brick, timber and fibrous cement sheet. The gable ends are lined with horizontal timber boards with simple timber bargeboards edging the small roof overhang. The upper, south facing facade has a bank of three timber framed casement windows to the centre.

A raised verandah extends along much of the southern, main facade, including the projected western section and returns to the north to form a terrace for the main entrance. The verandah roof is separate from the main roof and has been clad with matching tiles. Verandah detail includes shallow scalloped timber edging boards, and wrought iron posts which may date from the 1960s. The verandah floor is stone lined, and matches the

garden stonework. Windows are generally casements to the older sections of the house, although the cottage to the north-west has timber framed double hung windows and the skillion roofed additions have recent, rectangular timber windows.

Good

Major Alterations
