Victorian Heritage Database Report  
**St Hilda's Church**

457 Macclesfield - Yellingbo Road, Macclesfield VIC 3782 - Property No 63089

**Heritage Overlay Number: HO221**

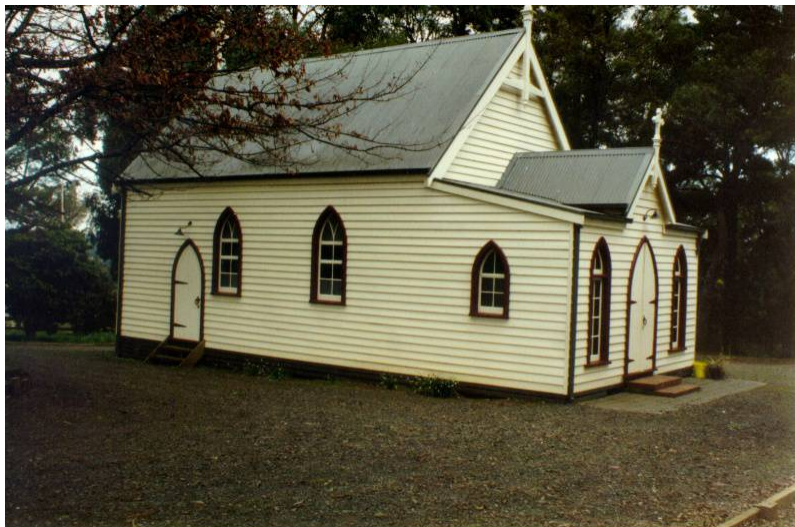
St Hilda's Anglican Church is set on a sloping site overlooking Macclesfield Road to the east. The grounds have largely been cleared, although some mature trees remain on the site's boundary. The Church Hall is also located on site, directly behind St. Hilda's Church which obscures it from the driveway entrance. It is a more recent development which is similar in scale, form and material.

The modest timber church is built in the Federation Gothic style and has a rectangular plan with a steep gabled roof and a small skillion roofed section to the west. The skillion roofed addition incorporates a second, smaller gabled roof to highlight the Church's west-facing entrance. The west facade of the Church is symmetrical, with centrally located, pointed arch timber double doors, flanked by a large, pointed arch, multi pane window to either side.

The north and south facades are almost identical and include two, regularly spaced pointed arch windows to the gable roofed section of the Church, and a single, more modestly proportioned one to the skillion roofed section. The windows are multi-paned and include simple timber tracery within the upper, arched window. The south facade incorporates an additional door close to the front corner while the east facade has a centrally located pointed arch window to match those on the side elevations.

The Church appears to be relatively intact, although the skillion roofed addition may be a later extension.
