Victorian Heritage Database Report
St Hilda's Church

457 Macclesfield - Yellingbo Road, Macclesfield VIC 3782 - Property No 63089

Heritage Overlay Number: HO221

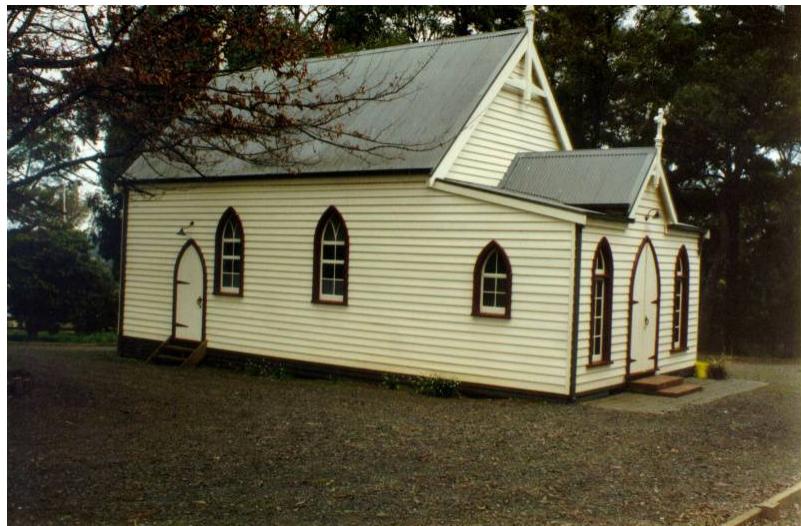
The modest timber church is built in the Federation Gothic style and has a rectangular plan with a steep gabled roof and a small skillion roofed section to the west. The skillion roofed addition incorporates a second, smaller gabled roof to highlight the Church's west-facing entrance. The west facade of the Church is symmetrical, with centrally located, pointed arch timber double doors, flanked by a large, pointed arch, multi pane window to either side.

The north and south facades are almost identical and include two, regularly spaced pointed arch windows to the gable roofed section of the Church, and a single, more modestly proportioned one to the skillion roofed section. The windows are multi-paned and include simple timber tracery within the upper, arched window. The south facade incorporates an additional door close to the front corner while the east facade has a centrally located pointed arch window to match those on the side elevations.

The Church appears to be relatively intact, although the skillion roofed addition may be a later extension.
