Victorian Heritage Database Report
The Log Cabin

1510 Mt Dandenong Tourist Road, Mt Dandenong VIC 1510 - Property No 21060

Heritage Overlay Number: HO279

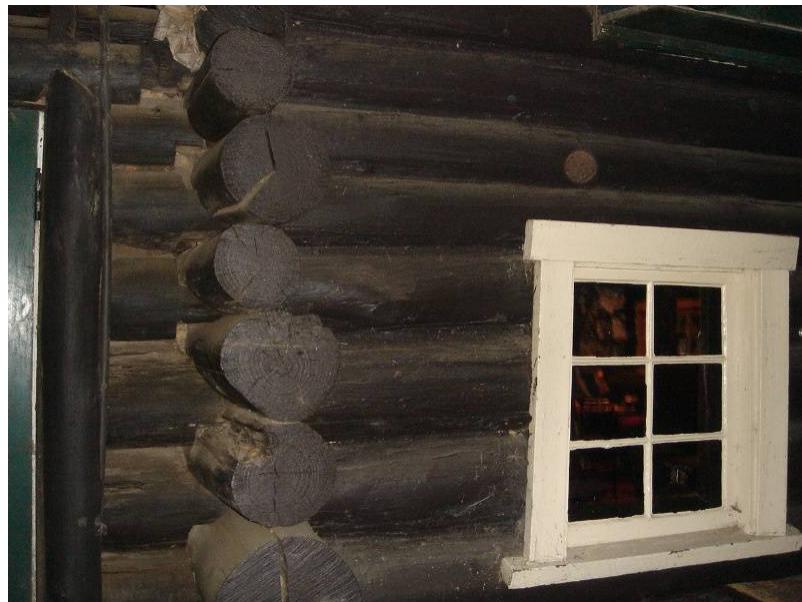
A small rectangular building with verandahs on three sides under a low pitched roof. The walls are entirely made of solid logs, notched together at the corners, and seamed with local clay. The verandah posts are also whole logs. The original twisted timber brackets to the verandah are no longer evident. There is a stone fireplace and chimney. There is also a much larger section of matching construction built in the 1970s. (National Trust Classification Report)

The Mt Dandenong and District Historical Society advises that no nails have been used in the construction of the building. Internally, there is a fine stone fireplace, built of stones collected from an old creek bed on the Basin-Olinda Road. Chairs and tables were also made by Jack Dodd. He treated the logs internally and externally with equal parts of boiled oil, kerosene and vinegar. The earth floor was covered with flour bags and coconut matting. Twice a year the matting and bags were lifted and shaken in the back yard. Afterwards it all took a week to settle and had an "ocean wave" appearance. (Submission 2 Dec. 1999)
