Victorian Heritage Database Report  
**The Log Cabin**

1510 Mt Dandenong Tourist Road, Mt Dandenong VIC 1510 - Property No 21060

**Heritage Overlay Number:** HO279

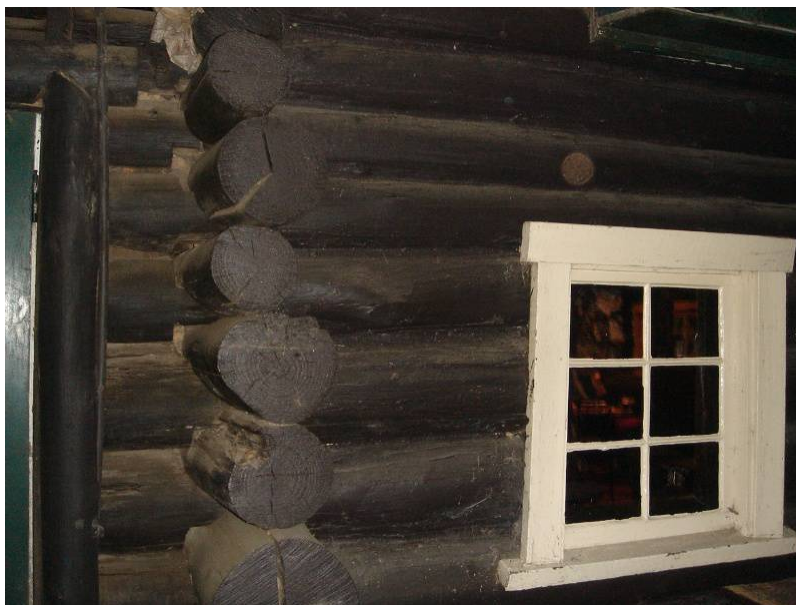
A small rectangular building with verandahs on three sides under a low pitched roof. The walls are entirely made of solid logs, notched together at the corners, and seamed with local clay. The verandah posts are also whole logs. The original twisted timber brackets to the verandah are no longer evident. There is a stone fireplace and chimney. There is also a much larger section of matching construction built in the 1970s. (National Trust Classification Report)

The Mt Dandenong and District Historical Society advises that no nails have been used in the construction of the building. Internally, there is a fine stone fireplace, built of stones collected from an old creek bed on the Basin-Olinda Road. Chairs and tables were also made by Jack Dodd. He treated the logs internally and externally with equal parts of boiled oil, kerosene and vinegar. The earth floor was covered with flour bags and coconut matting. Twice a year the matting and bags were lifted and shaken in the back yard. Afterwards it all took a week to settle and had an "ocean wave" appearance. (Submission 2 Dec. 1999)
