**Victorian Heritage Database Report
Wallace House**

473 Warburton Highway, Seville VIC 3139 - Property No 14923

Heritage Overlay Number: HO300

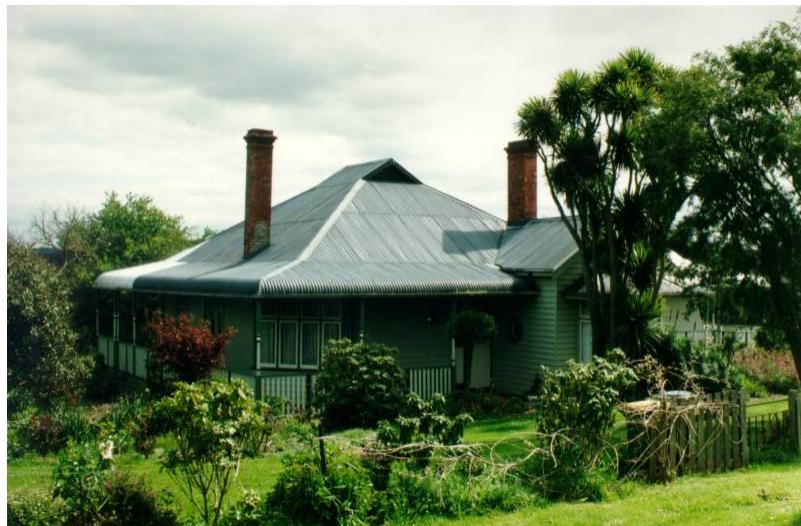
Wallace House dates from the turn of the century and is a square plan timber house built in the Federation style. It has a combination of steeply sloped hipped and gable roofs with a return verandah and decorative timber work. The verandah extends from the projecting gable roofed section to the south-east corner along three sides of the house. Its roof is an extension of the main hipped roof, with a shallower slope, and has a bullnose profile. This makes the roof the most dominant feature of the house. A modern addition built in the same style as the historic house extends from the east elevation around a courtyard garden.

Decorative elements include projecting bay windows, located on the south-west corner of the house beneath the verandah roof, and the separately roofed bay on the projecting wing facing Wallace Road. The bay windows each have a set of four rectangular, timber frame casement windows with square highlights, while the windows located elsewhere are double casements with similar highlight windows. A small porthole window is located adjacent to the main entrance. The verandah balustrade is constructed from panels of plain timber pickets between regularly spaced, turned timber posts.
