Victorian Heritage Database Report  
**Woori Yallock Bridge**

**Heritage Inventory (HI) Number: H8022-0094**

**Heritage Overlay Number: HO365**

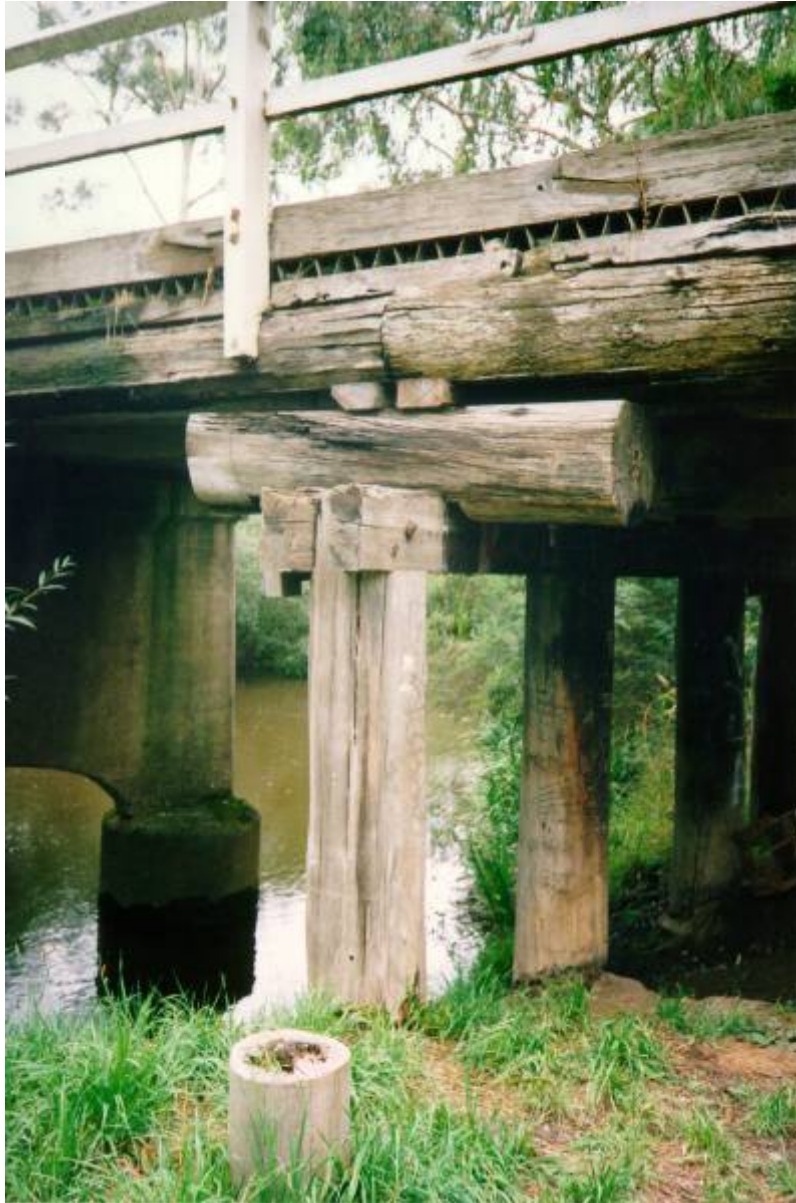
The Woori Yallock bridge is of regional significance as the earliest known through-type timber truss bridge, supported on concrete piers built in Victoria. It is contemporary with the later larger Genoa Bridge. (McInnes 2000) It is earliest surviving example of a timber bridge across the Yarra River within the Yarra Ranges Shire. (National Trust 1998). Its design is associated with two significant engineers in Victorian (and Australian) road bridge history, T.H. Upton and D.V. Darwin. Its setting, with the riparian vegetation along the river and road cutting contributes to its significance.

Concrete bridge with timber supports and buttresses about 120m long. It has several sections in order to cross the Yarra Flats and associated billabongs. (Supple, 1991)

During the present study, the Shire commissioned a specialist heritage engineer to examine the bridge and report on its significance. The engineer's report has been drawn on in revising this assessment; further detailed information may be found in that report. This report identifies that the significant elements of the original structure that remain are: the concrete piers (original); remnants of the original five cross girders for the truss span; squared timber beams; timber abutments; timber pier; round log timber girder and corbels; timber kerb and handrail. He comments that some of the timber elements may not be original but are in the form of the original. He also notes remnant of cut sandstone blocks under the bridge to the southern side, suggesting that these may have some from an earlier structure. (McInnes, 2000)
